THE OLD NAVAL HOSPITAL

HISTORIC STRUCTURE REPORT

June 30, 1994

The Old Naval Hospital
(The Center for Youth Services)

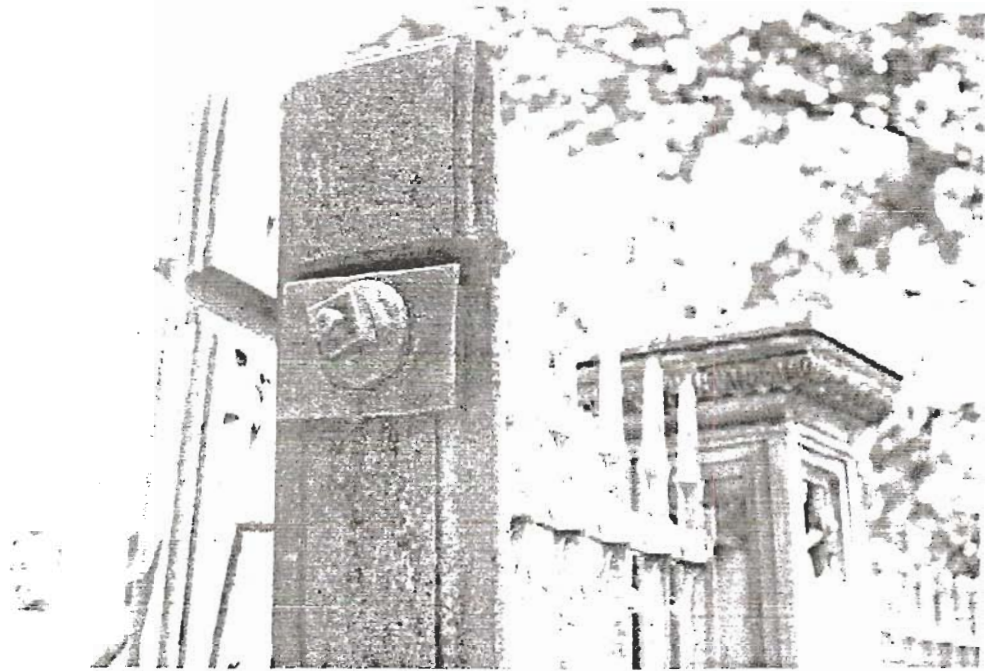
Figure 83 Detail at Capital of Damaged Cast Iron Fence Columns (South Gate).

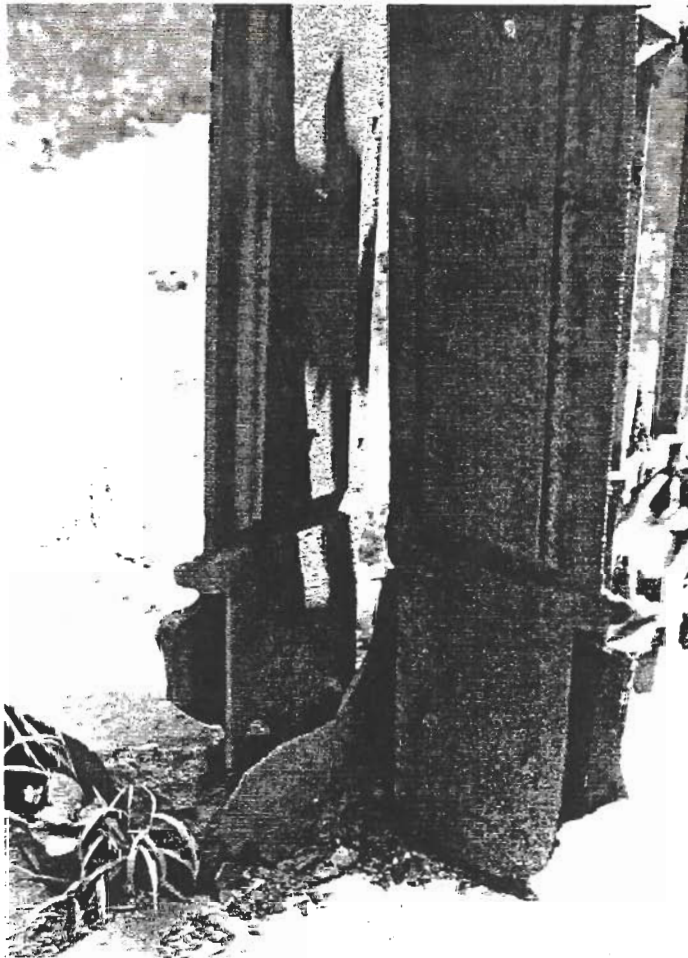
Figure 82 Detail at Base of Damaged Cast Iron Fence Columns (South Gate).

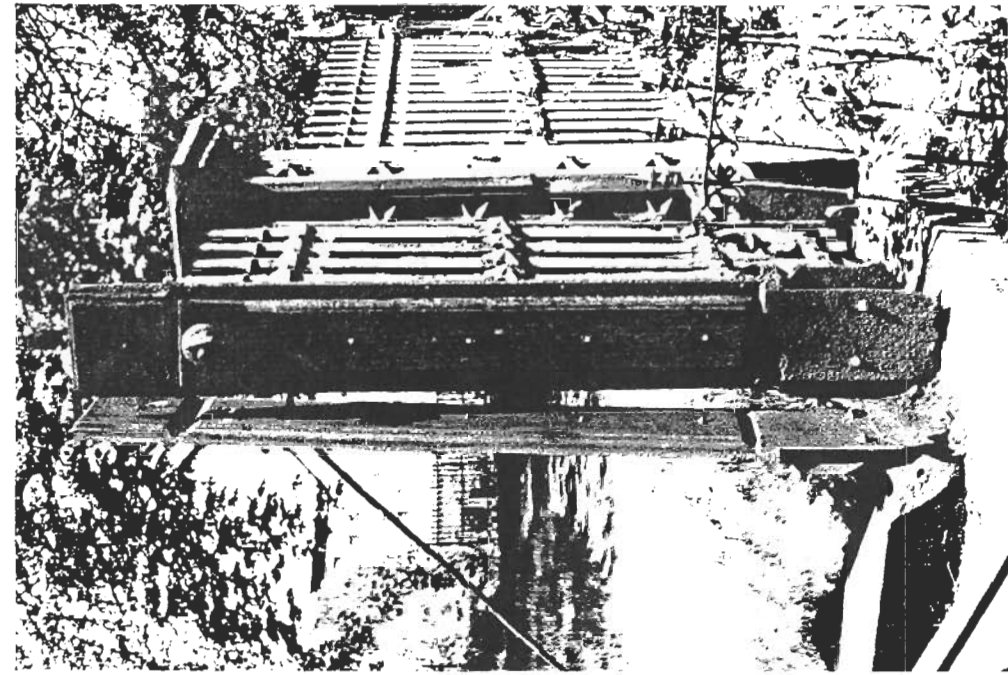
Figure 84

South Site Entry Showing Deteriorating Cast Iron Gatepost.

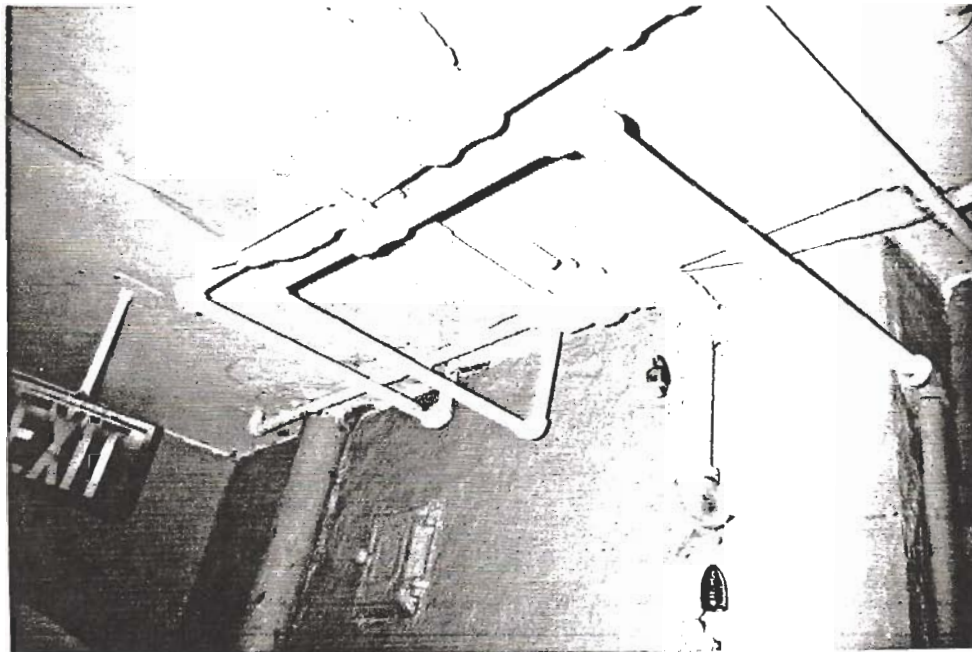
Figure 121 Basement Water Damage on Ceiling Above West Exit.*

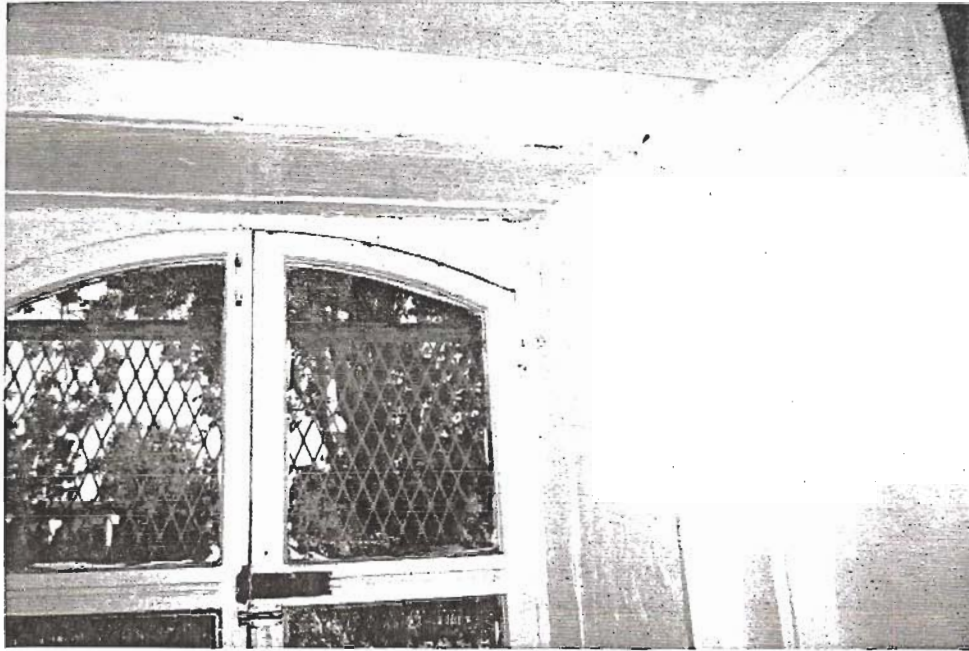
Figure 122 Basement Window Trim Damage.*

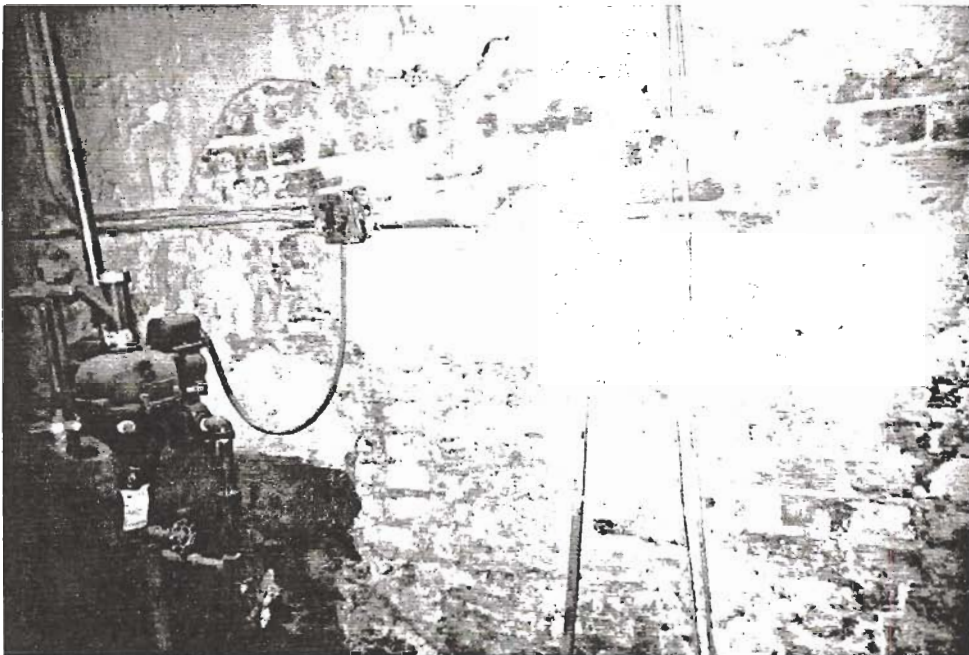
Figure 123 Basement Mechanical Room, Damage to Brick Wall and Plaster.*

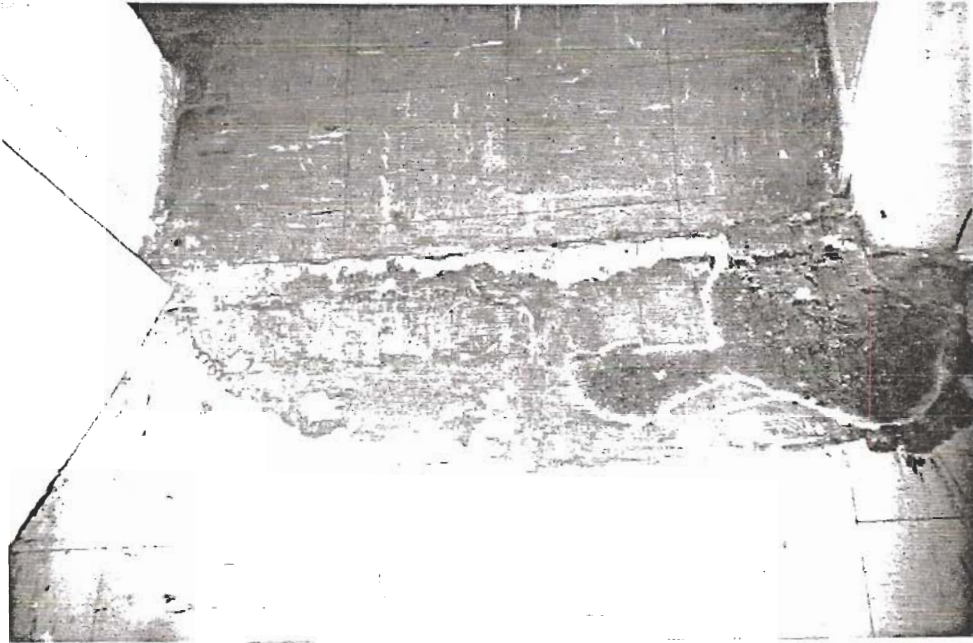
Figure 126 Basement Level Damage at Vinyl Floor at Entry to Kitchen.*

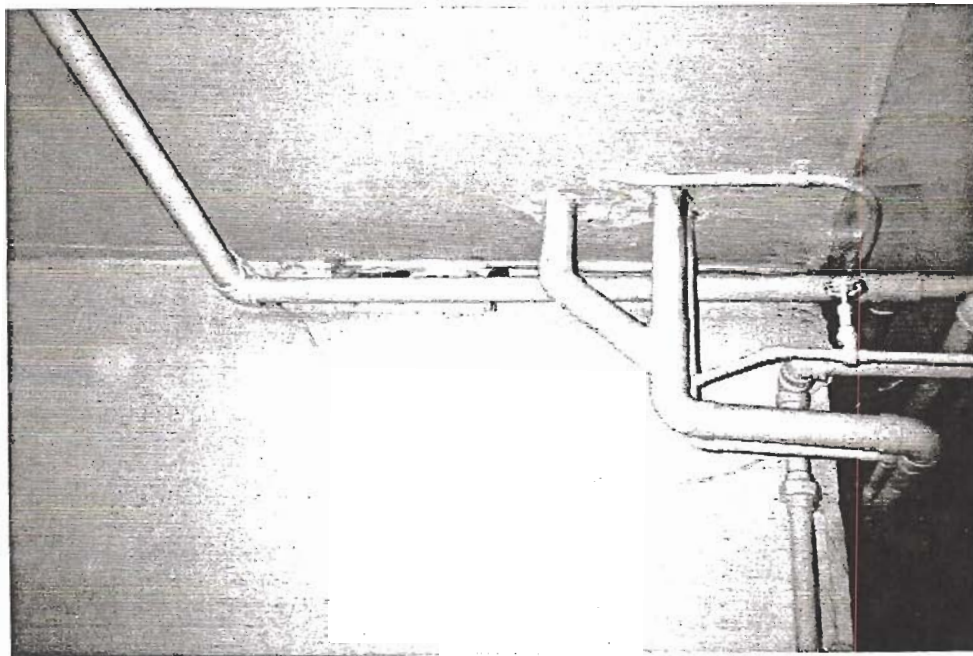
Figure 127 Basement Corridor: Water Damage on Ceiling Around Exposed Pipes.*

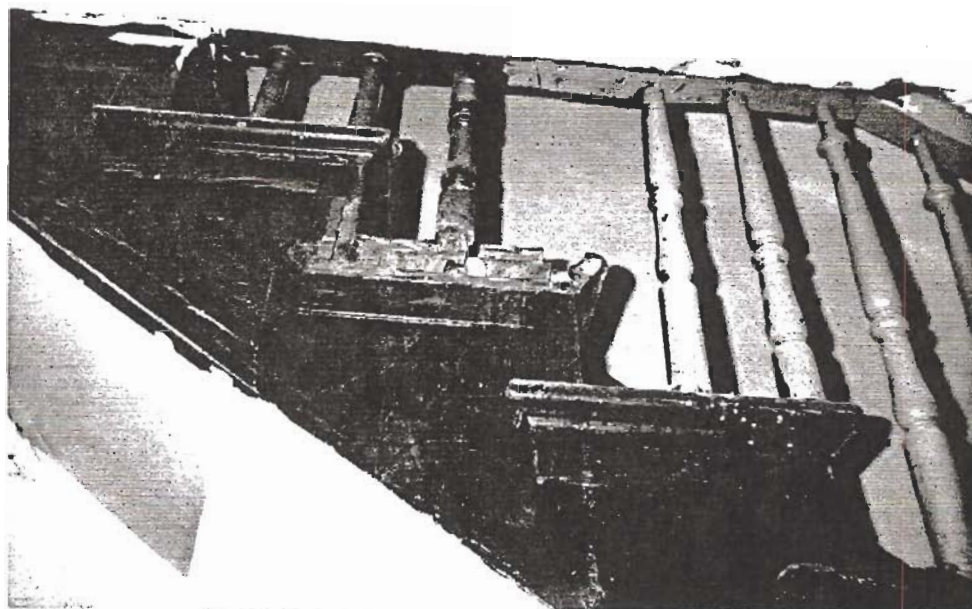
Figure 131 Basement: Damaged Wood Railing and Stair.*

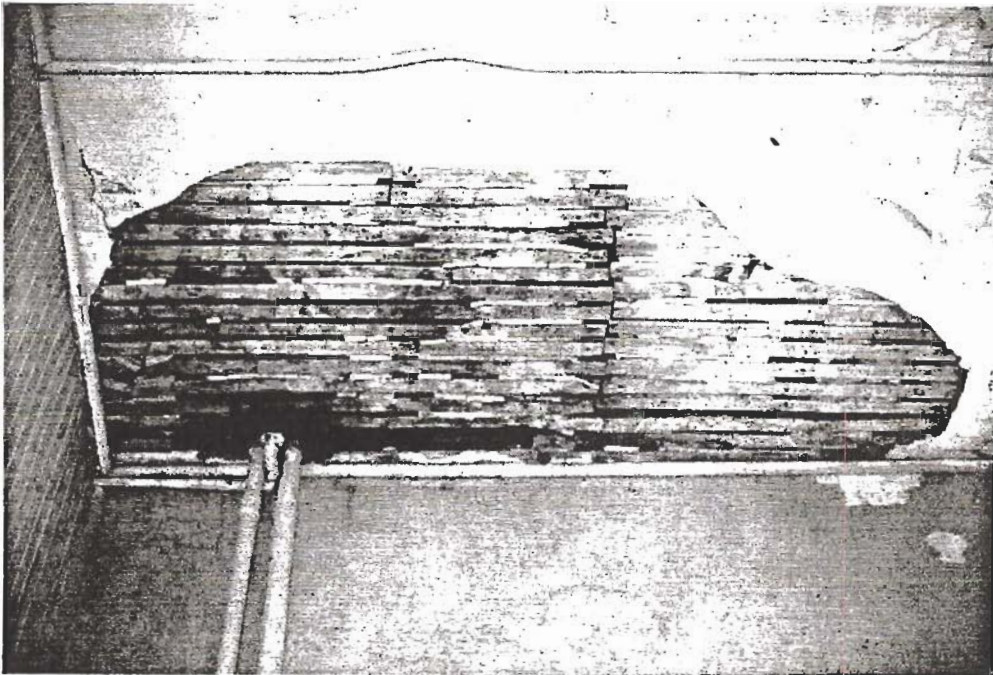
Figure 145 First Floor: Water Damage to Ceiling.

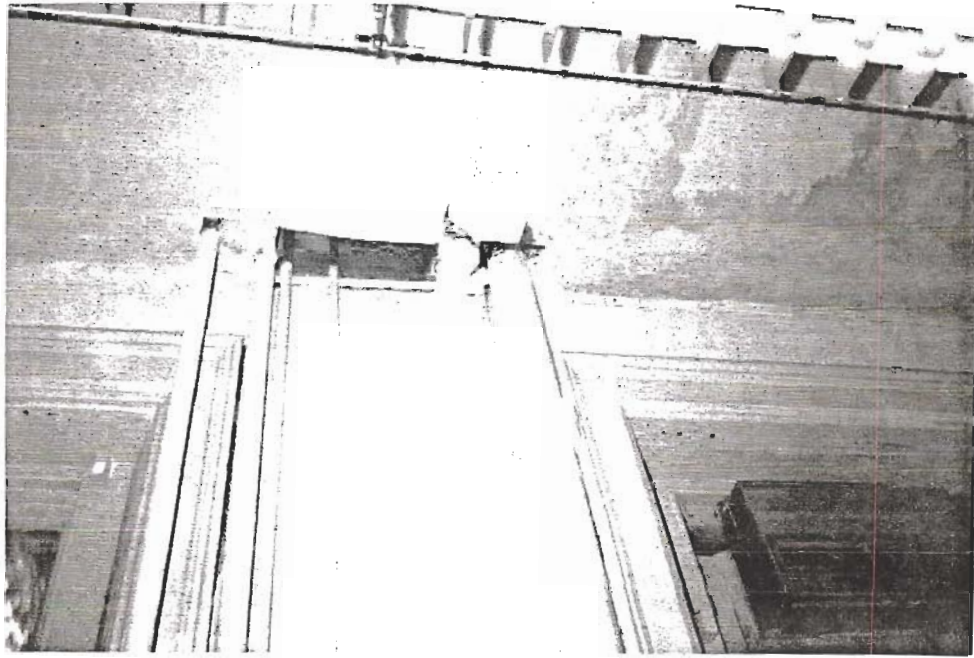
Figure 146 First Floor: Ceiling Plaster Damage and Water Stains.*

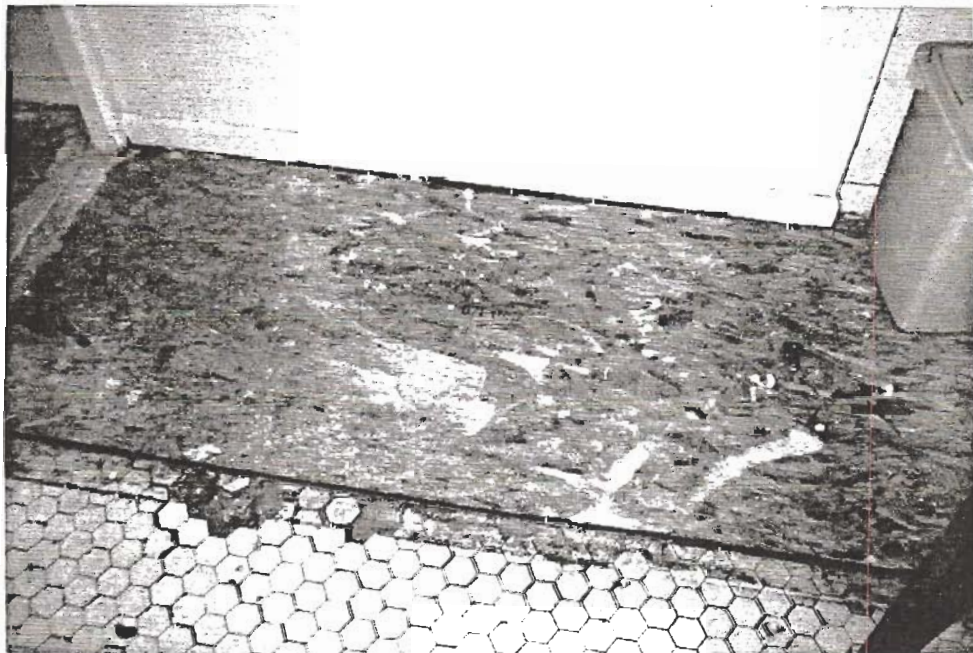
Figure 147 Second Floor: Missing and Damaged Tiles at Women's Bathroom.*

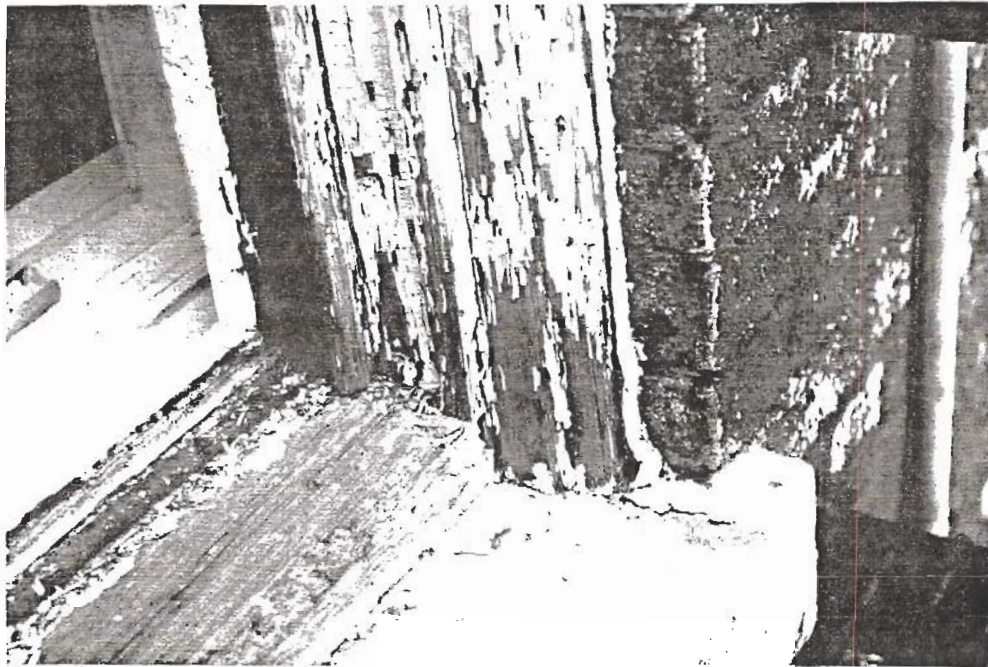
Figure 148 Deteriorated Window Jamb and Sill Detail at East Facade.

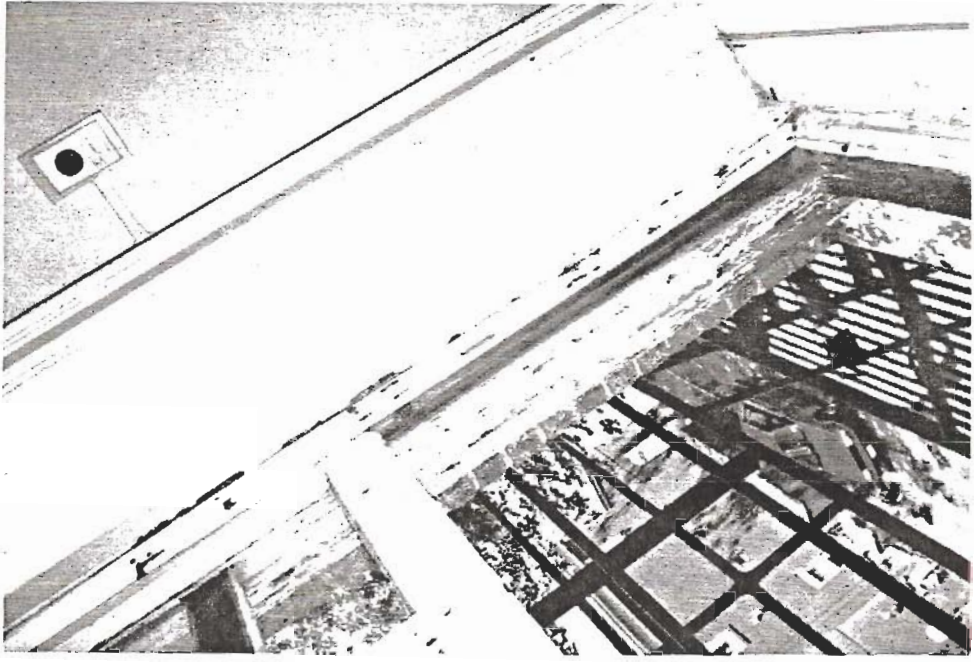
Figure 151 Second Floor: Window Dry Rot.*

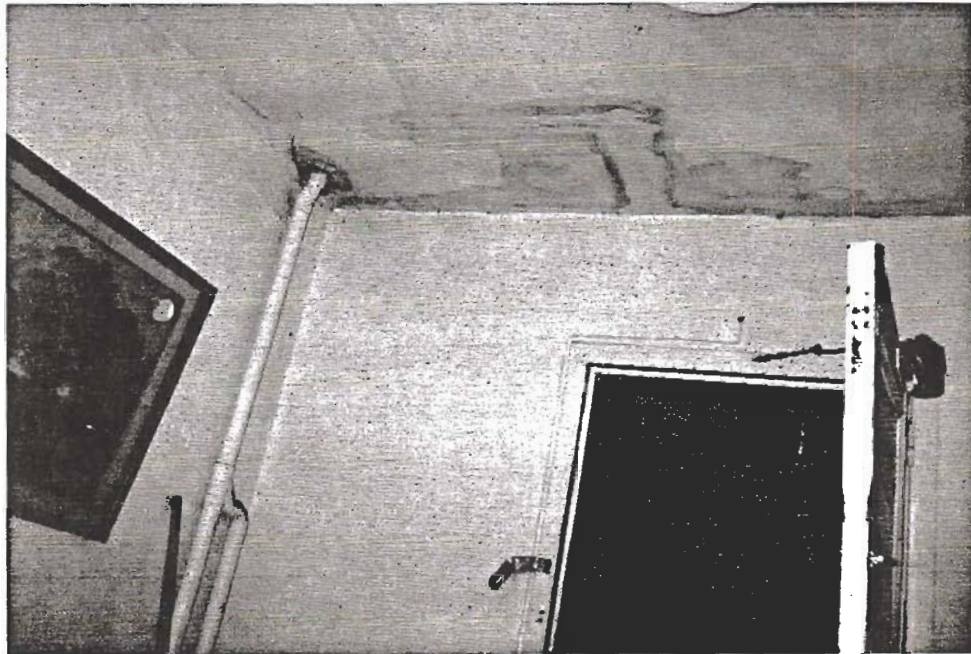
Figure 153 Third Floor Landing: Water Damage at Ceiling.*
