Rehabilitation of the Old Naval Hospital

A Technical Report

Friends of the Old Naval Hospital

January 30, 2002
Friends of the Old Naval Hospital
907 E Street SE
Washington, D. C. 20003
202-544-4627

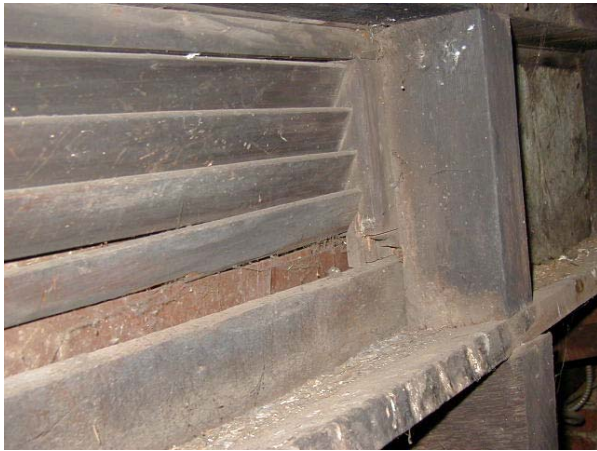
Blocked Vents

D. Recommendation: The roof and drainage work must be done by qualified roof restoration specialists and not just a low bid roofer. The specifications must be written so that the bidder has to prove current experience and background in historic roof restoration of this period with at least five examples of similar work in the last seven years. In addition, the bird droppings and other loose materials must also be removed and screens installed to prevent bird penetration under the roof.

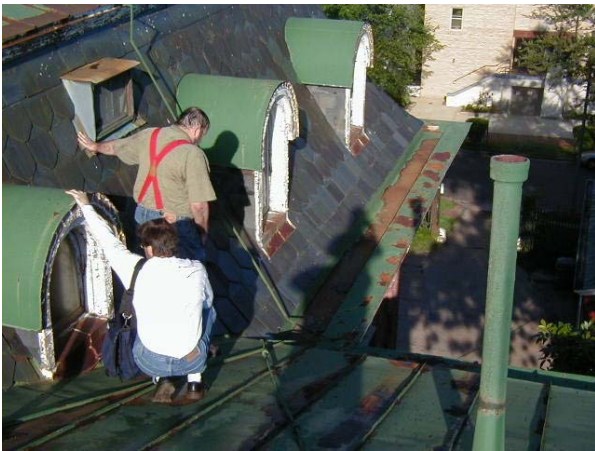
Roof and Dormers

Current: The slate on the roof is in generally good shape, with some replacement needed in specific areas where there has been exfoliation and cracking of the slate. Some slate shingles are missing. The seamed metal part of the roof seems watertight, but needs to be lightly scraped, repaired and painted. The interior of the roof is for the most part, totally dry and without problems, with only a few hints of leakage which need to be repaired. There have been some minor repairs to the interior structure over the years.

Description: No extensive restoration is needed although the areas showing some water leakage needs to be investigated and repaired. The seamed metal roof needs to be completely cleaned and thoroughly repaired and then painted in the color of the original paint (probably a green—this must be determined by a paint analysis) with a fibrous sealant paint. For the slate part of the roof, period slate shingles must be replaced in kind.

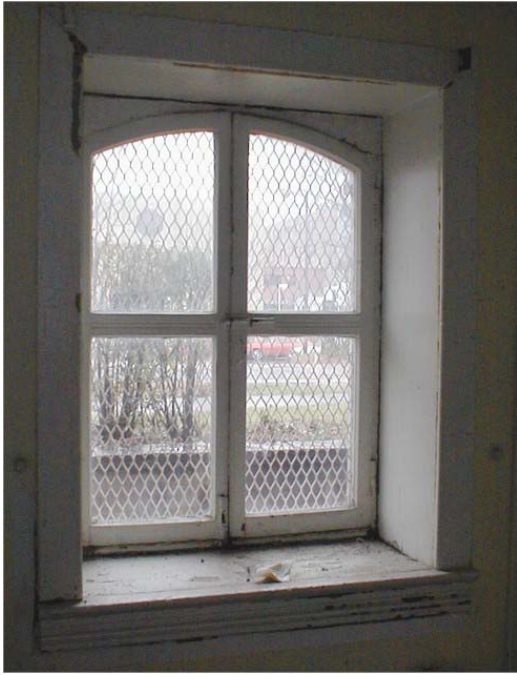
Basement Type 2 Windows

Current: The Type 2 windows are in reasonably good shape needing only restoration. There is some original hardware which can be restored. The type 2 windows sashes need replacing with sashes similar to the extant Type 2 units. The type 3, 4 and 5 windows need to be researched and replaced.

Original: The best example of the Type 2 window is the second window in from the northwest corner. The surrounds and windows are in good shape on the original windows, needing only restoration. Hardware needs to be restored and where missing, replaced in kind.

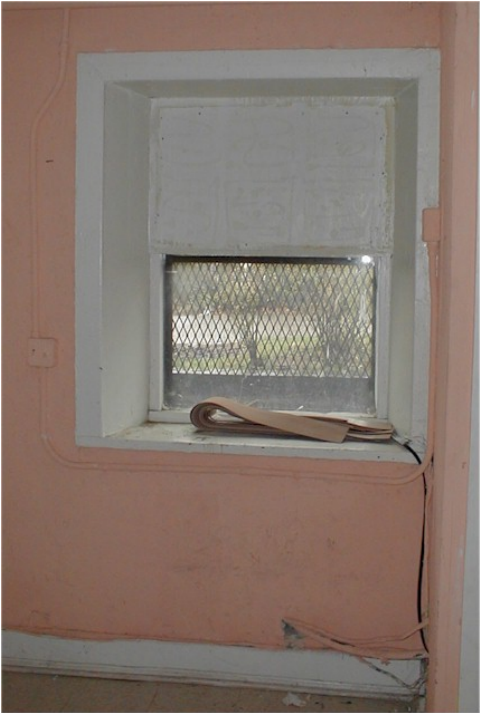
Basement Type 3 Window

Added: The AC units are in poor shape, but should be eliminated regardless. The Type 3, 4 and 5 windows need to be replaced.

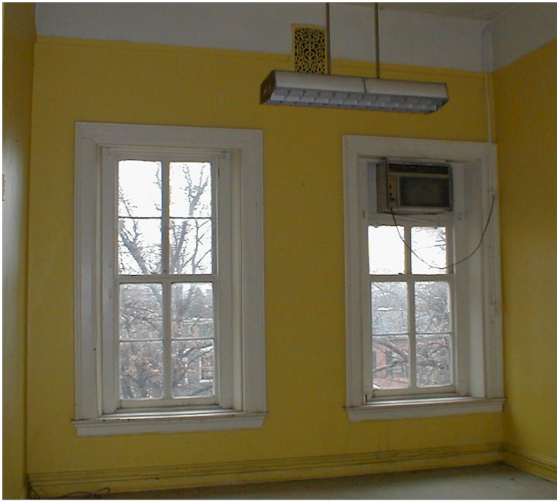
First Floor: Type 6 and 7 Windows

Current: Both type windows are in good shape. The air conditioning units are in need of replacement (or elimination).

Original: The Type 6 windows are missing the top half of the upper sash where the AC unit was inserted. The lower sash is restorable while the upper sash was significantly altered. There are some muntins missing and there is inappropriate sealant on some of the windows.

Inappropriate sealant was used on some windows for glazing the exterior. The wood stool is severely deteriorated and most of the windows have missing hardware, although some have the cord and weights from the double hung movement. Some windows have mismatched glass (eg. obscure or wired). Some interiors have been inappropriately stripped of paint.

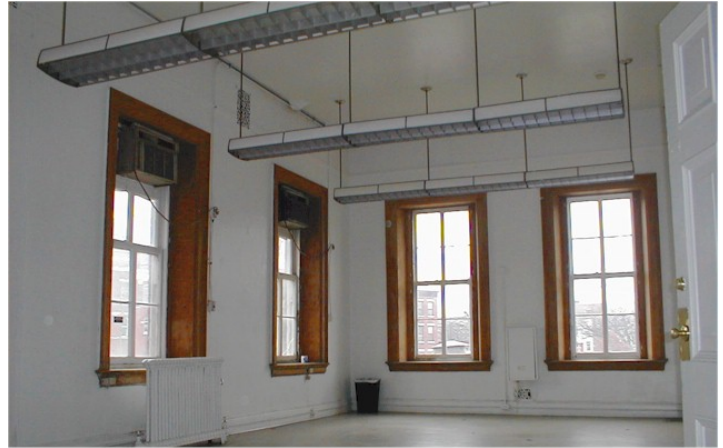
Second Floor Type 8 and 9 Windows

Current: Type 8 windows are similar in condition to the Type 6 windows on the first floor. There is early glass in the lower sash of the window second from the left on the north elevation.

Type 9 windows are similar in condition to the Type 7 windows on the first floor. There is early glass (broken) in the second window from the right on the east elevation and five panes on the left most window on the east elevation. There is also evidence of interior shutters separately for the upper and lower sashes as indicated by the hinge recesses in the interior jambs next to the sashes.

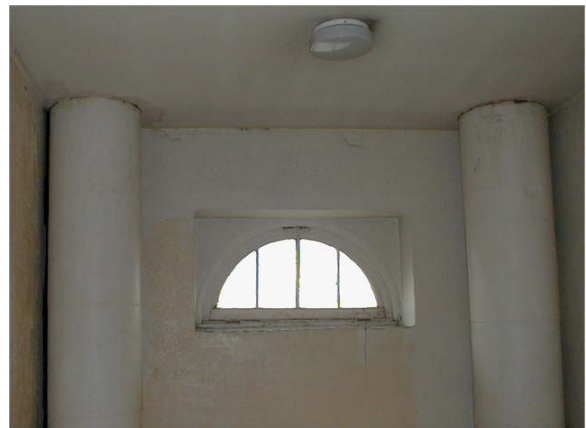
Third Floor: Type 14 Window

Type 14 is a fixed window with missing hardware.

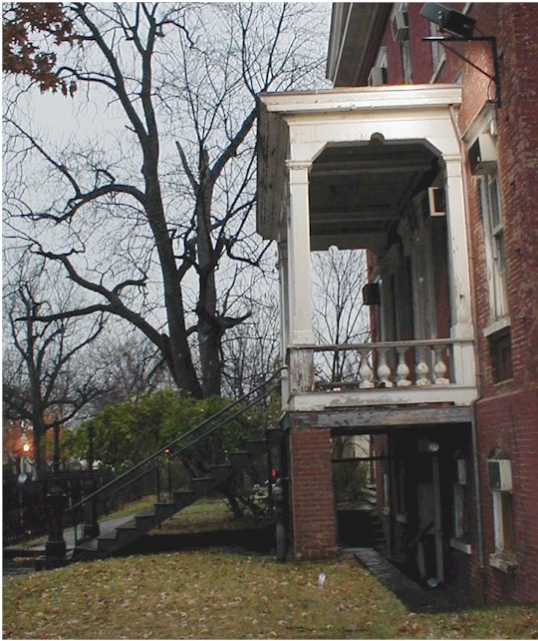
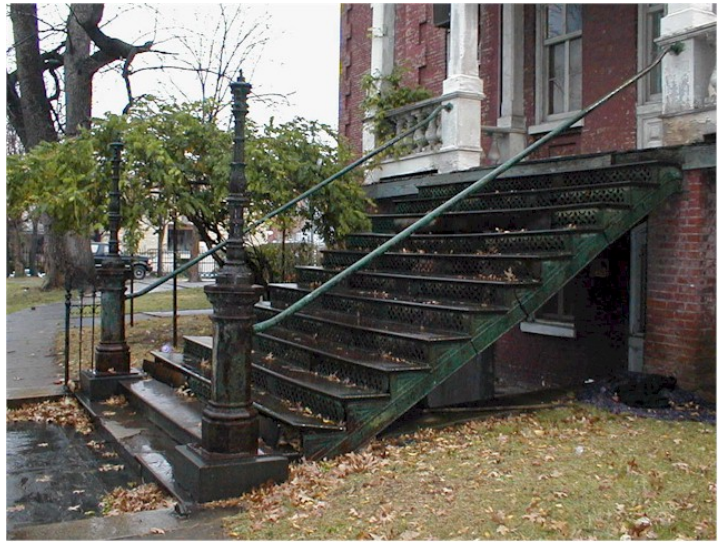
Main Exterior Staircase and Portico

Current: All the cast iron pieces need to be removed and restored. Major cracks in the cast iron stringers and kick plates make the staircase unsafe for use. Most of the clips and fasteners are deteriorated. The gaslight standards are missing the topmost lamp sections. The porch floor is becoming unsafe since it and some of the joists are seriously dry rotted (although many of the joists can be salvaged). The balustrade and pilasters are also in a deteriorated condition. The masonry is also in poor condition and the parging should be removed.

- 1) Label and identify all components of the stairs prior to disassembly.
- 2) Completely disassemble the stair case and transport it to the conservation studio.
- 3) Completely strip all coatings (lead positive) using hot caustic dip solution and phosphoric acid.
- 4) Recast all heavily damaged and/or missing risers in cast iron.
- 5) Fabricate new clips and points of attachments for the treads, risers, and stringers.
- 6) Repair by welding all cracked sections of stringers.
- 7) Repair by welding two sections of treads that are presently cracked.
- 8) Completely recoat stairs using powder coat or a paint system consisting of zinc-rich primer, epoxy mastic intermediate coat, and topcoat using aliphatic urethane.
- 9) Transport stairs back to the site and reinstall.
- 10) Provide complete documentation of the work in both written and photographic form.

The two brick piers holding the staircase must be inspected and restored and the masonry retaining wall must be rebuilt and restored to address the deteriorating mortar.

The porch deck must be removed and replaced since there is substantial wood rot in the flooring, and the original joists restored. The end header beams should be redone and the pilasters and balustrade replaced.

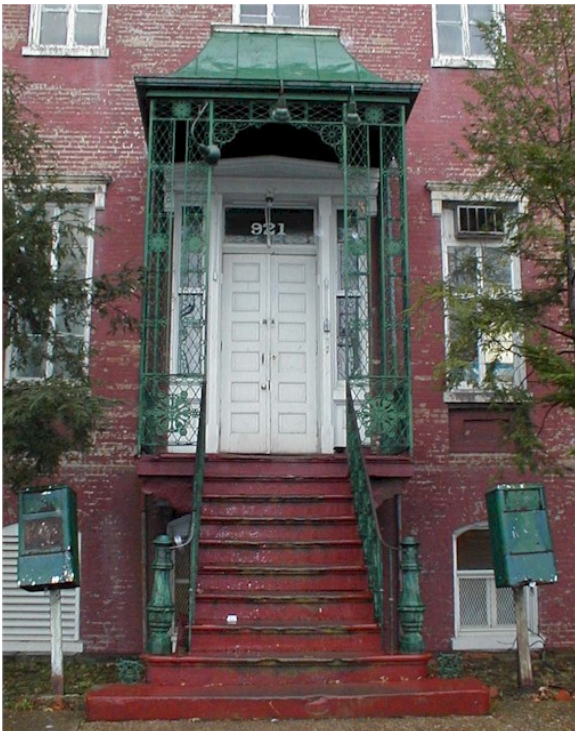
North Façade Staircase and Metalwork

North Facade—The fine wrought iron filigree is in good shape needing only light restoration, the down spouts are nearly non-existent, the guttering has pinholes, the leftmost of the two boot scrapers is damaged, the cast iron newels are in good shape needing restoration, the metal roof over the entrance needs light repair and repainting, the gas fixture needs to be researched and restored and the lightening rod system needs to be repaired and reanchored.

North Facade—The guttering needs to be repaired and the down spouts need to be replaced.

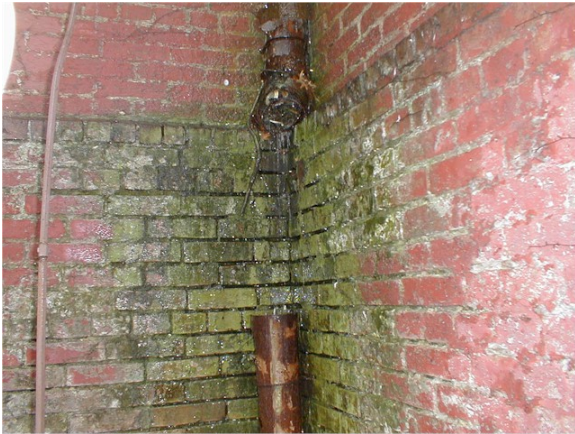
Current: General—The painted brickwork is in generally good shape but with the majority of the paint peeling or off. The bottom six courses have severely eroded mortar due to water damage. Brick damage, caused by improper mortar replacement, exists in various places. In other places, moss and ivy are growing out of the joints, destroying the mortar.

Brick and Mortar Water Damage
