THE OLD NAVAL HOSPITAL

HISTORIC STRUCTURE REPORT

June 30, 1994

The Old Naval Hospital
(The Center for Youth Services)

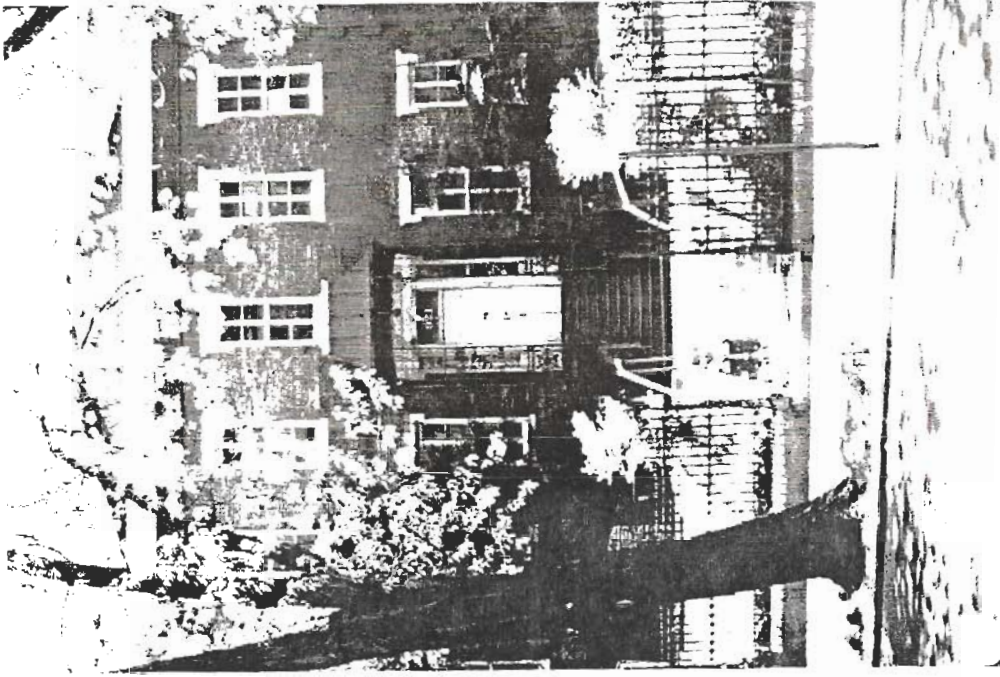
Figure 24 Cast Iron Fence Details on North Side of Site.

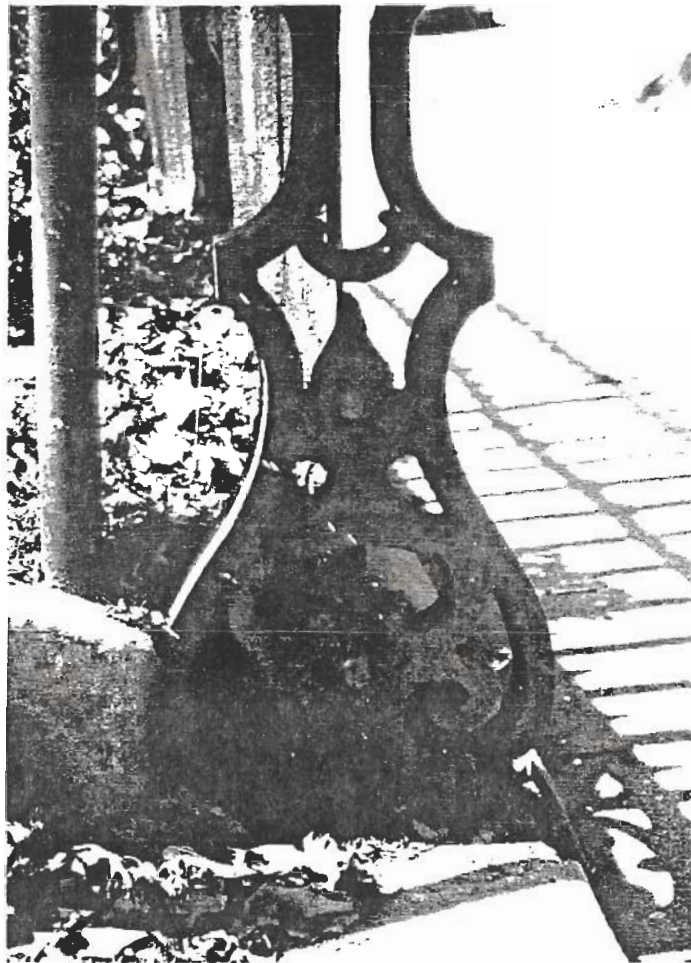
The condition and style of the main (north) entrance, (see Figures No. 44, 45, 132, and 133) cast iron work is characteristic of the ironwork exhibited around the site. A cast iron grillage trellis supports the standing seam bell shaped metal roof over the entry way (see Figure No. 25). The cast iron medallion with filigree (tracery) type detailing is rusting but substantially intact. The same medallion motif is repeated in several locations including the gazebo-like structure on the northeast side of the site, the north portico trellis, north stair rail, and the rooftop vent structure railing (see Figures No. 44, 45, 132 and 133). The flared stone stairs, bounded on both sides by cast iron railings are terminated by cast iron posts (see Figure No. 44) at the base. The stone risers and top landing are in good condition although several of the supporting stones have been dislodged (see Figure No. 133). The underside of the top landing platform is spalling due to water infiltration and is supported by a severely spalled stone bracket (see Figure No. 44).

Figure 25 North Entrance.

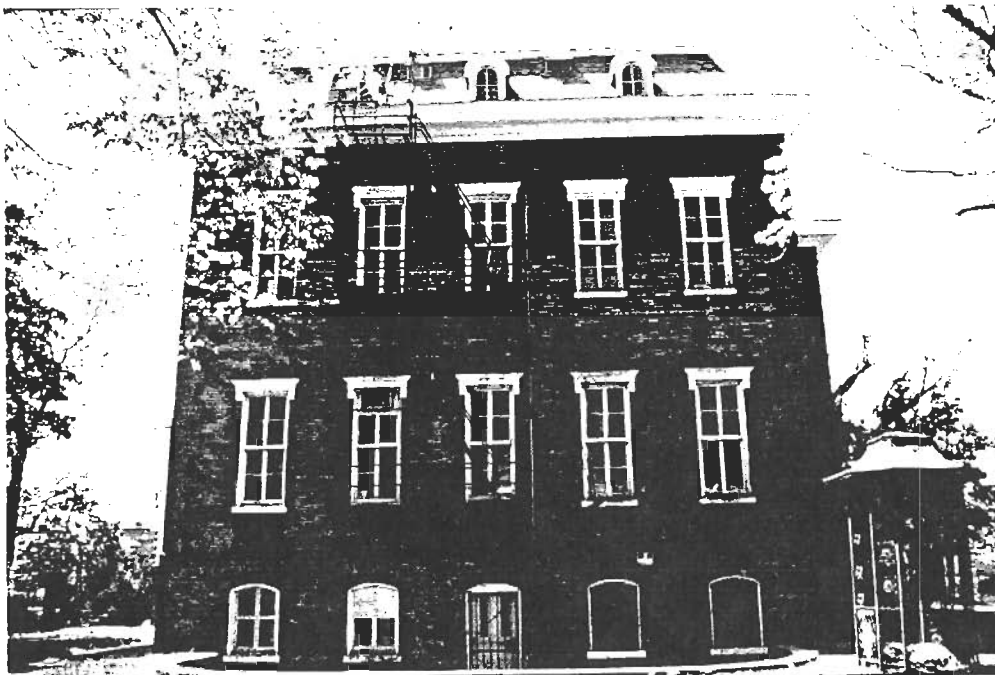
Figure 28 Cornice and Window Trim Details at East Elevation.

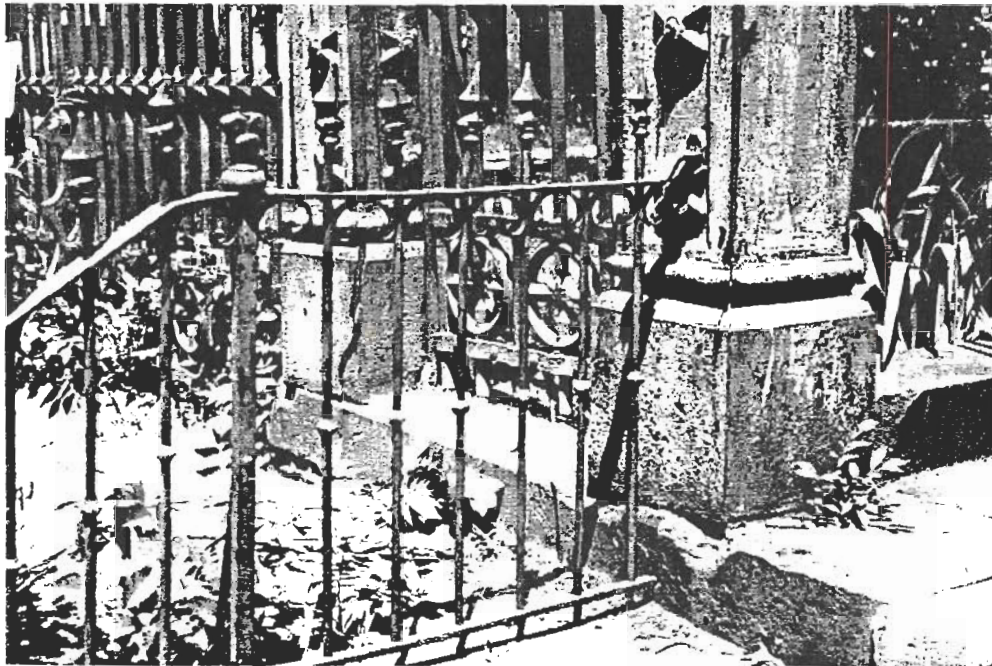
Figure 31 Cast Iron Fence Column Details at South Gate.

The most visible element defining the property is the heavy cast iron fence (see Figures No. 24, 25, 26, 31 and 34) set with lead in stone and concrete at the perimeter of the site (see Figures No. 24 and 31). The fence system runs continuously around the site terminating in detailed square columns (see Figures No. 82, 83, 84, and 85) at the corners and openings. The south (originally the main) entrance gate fence terminates in a doubled column motif (see Figures No. 31, 78, 83, 84 and 85). The columns consist four cast iron panels fastened together (see Figure No. 82 and 84) to form the shaft and base which supports a highly detailed egg and dart motif capital topped with a finial (see Figure No. 33). The west side opening near the former stable has one remaining panel of a swinging gate. This opening is bracketed by a single column motif. The north opening appears not to have been original. The intermediate fence support forms the termination of the opening, atypical for this site (see Figures

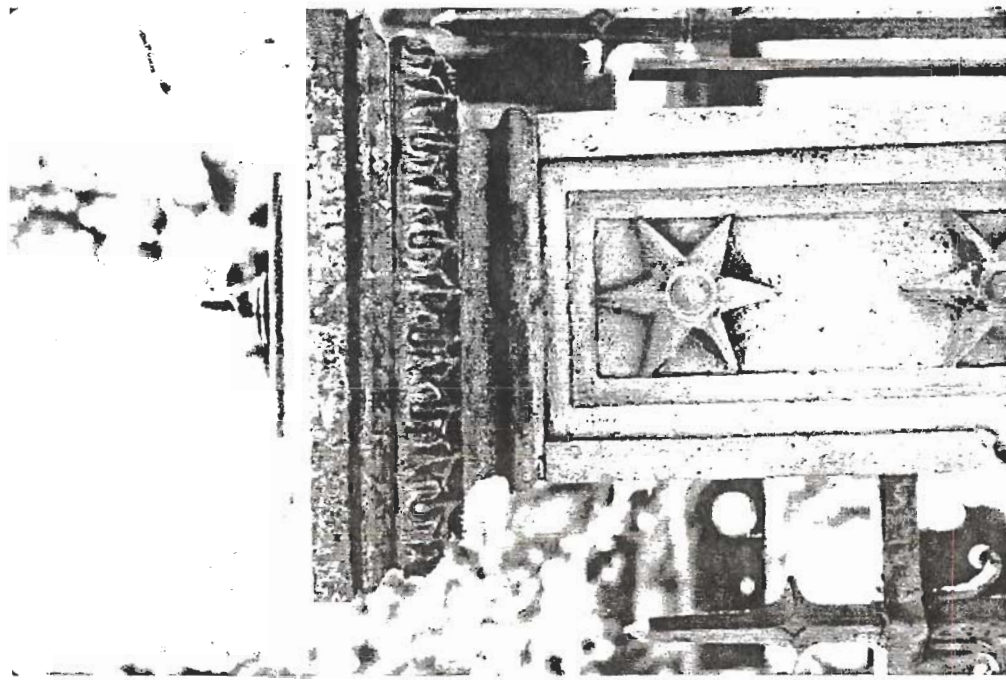
Figure 33 Cast Iron Fence Column Capital Detail at South Gate.

In general the fence is in a severe state of disrepair (see Figures No. 79 and 81). Several sections are on the ground and many others are loose and in danger of collapse. Less than 50 percent of the column capitals remain (see Figures No. 33, 82, 83, 84 and 85) and several have panels missing or separated from each other. The integrity of the heavy gauge individual fence sections is generally intact but the connections between sections has broken down in places.

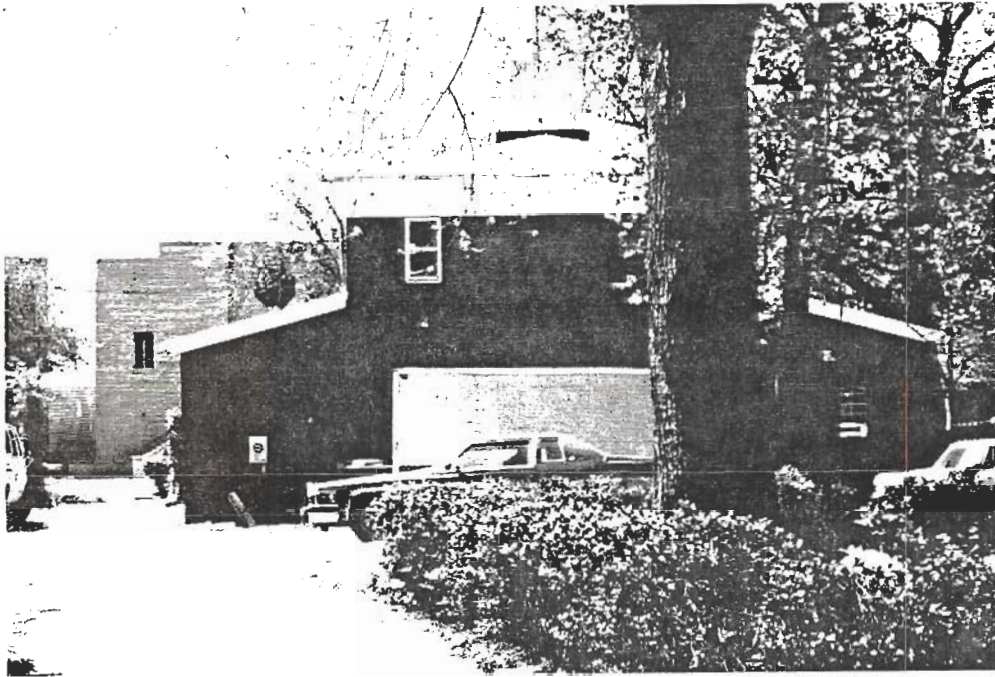
Figure 35 West Elevation of Ancillary Building (Former Stable) on Site.

The running bond brickwork of the ancillary site structure (see Figures No. 35 and 36) is also in good condition. The building has few details. The one-and-a-half story building has symmetrical window openings at the principal facade with heavy stone lintels over both windows and doors.

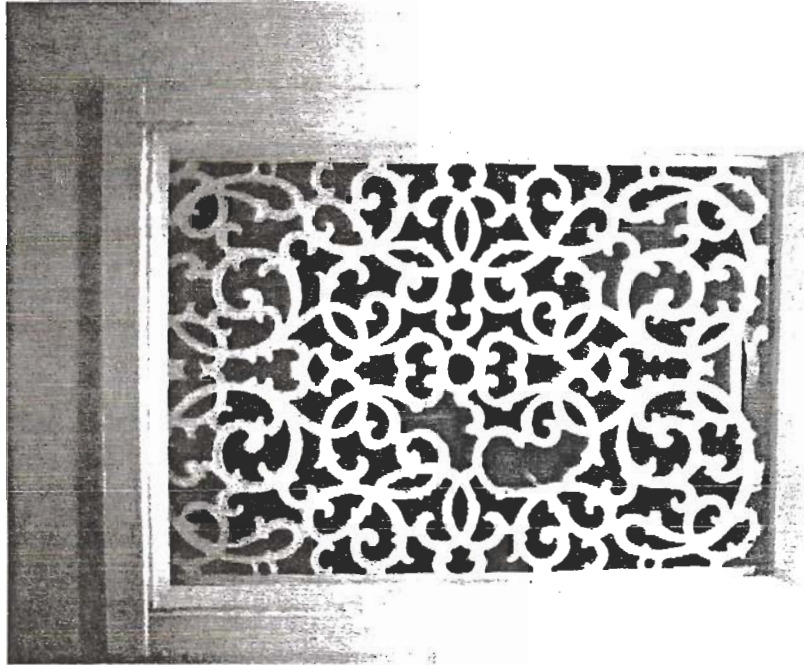
Figure 73 Third Floor Cast Iron Circular Radiator Detail.

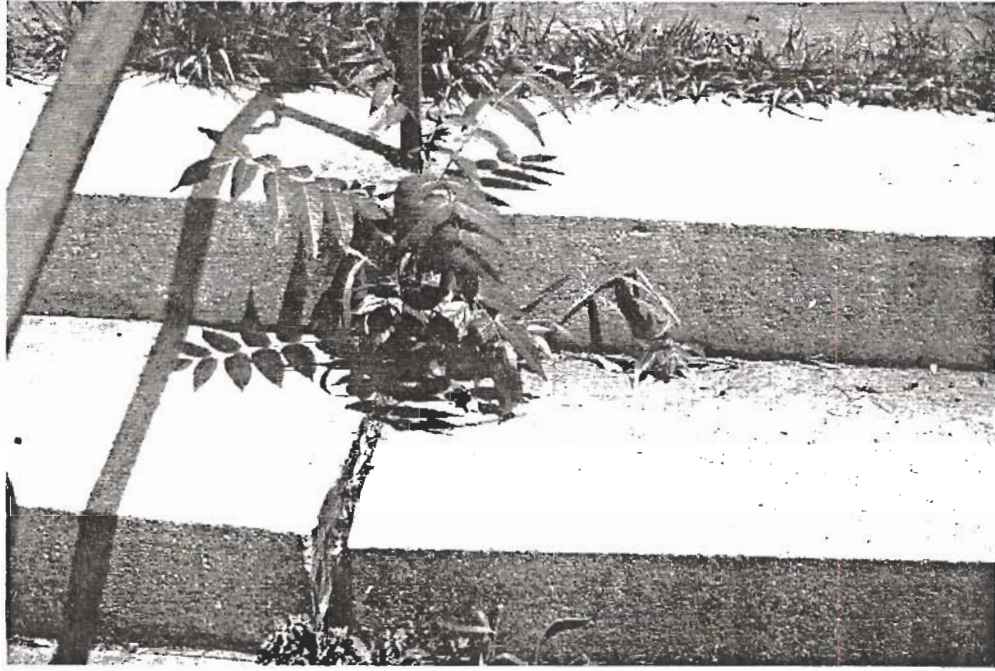
Figure 79 Stone Stairs at South Entrance Gate.*

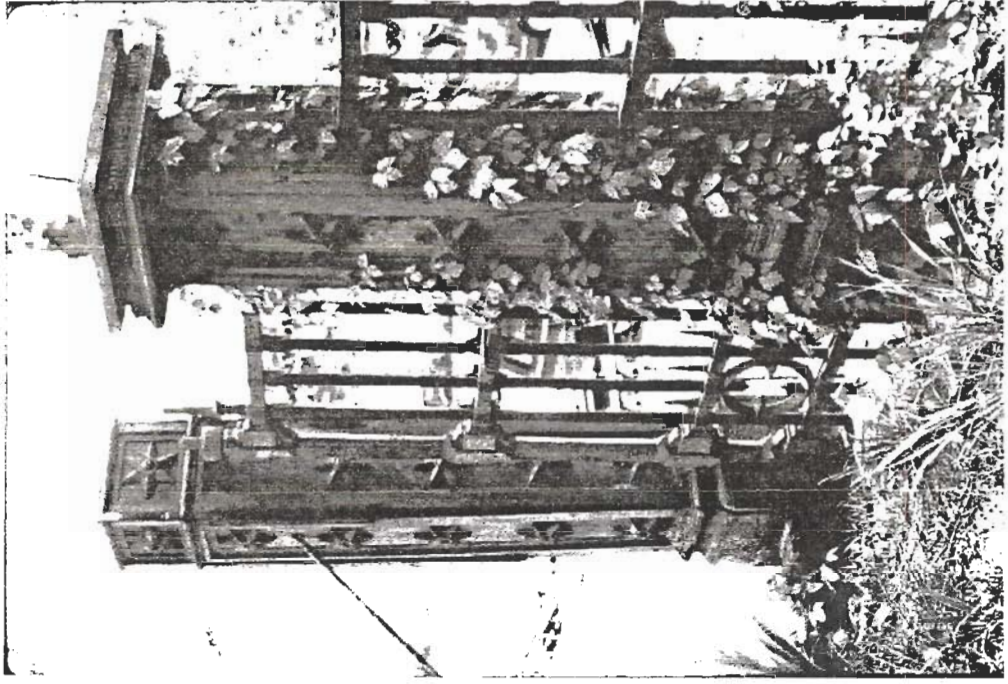
Figure 84

South Site Entry Showing Deteriorating Cast Iron Gatepost.

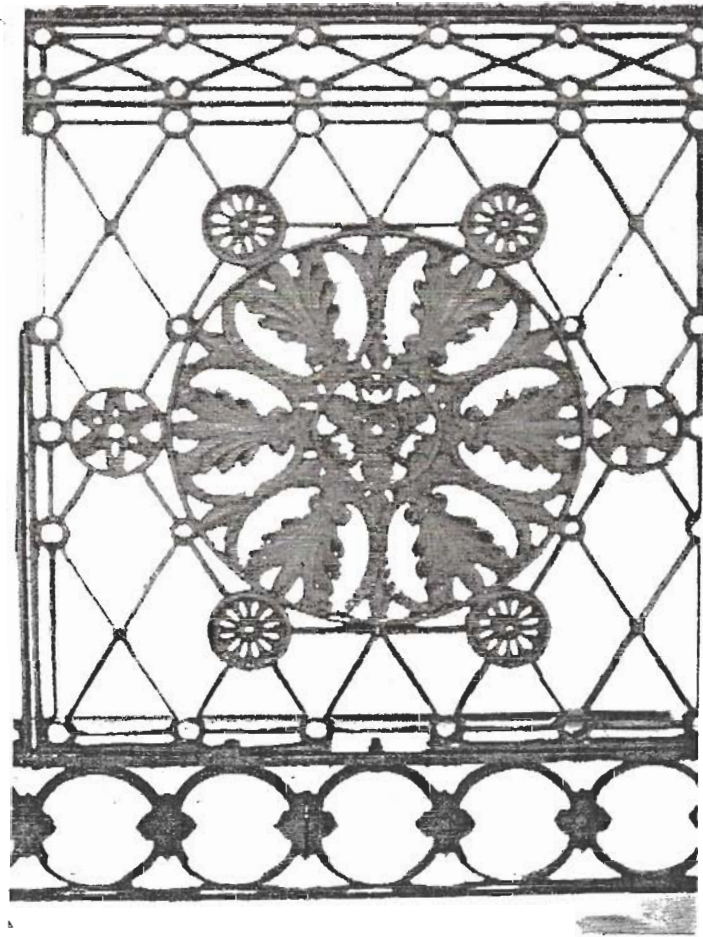
Figure 85

Cast Iron Fence Detail at South Site Entry.

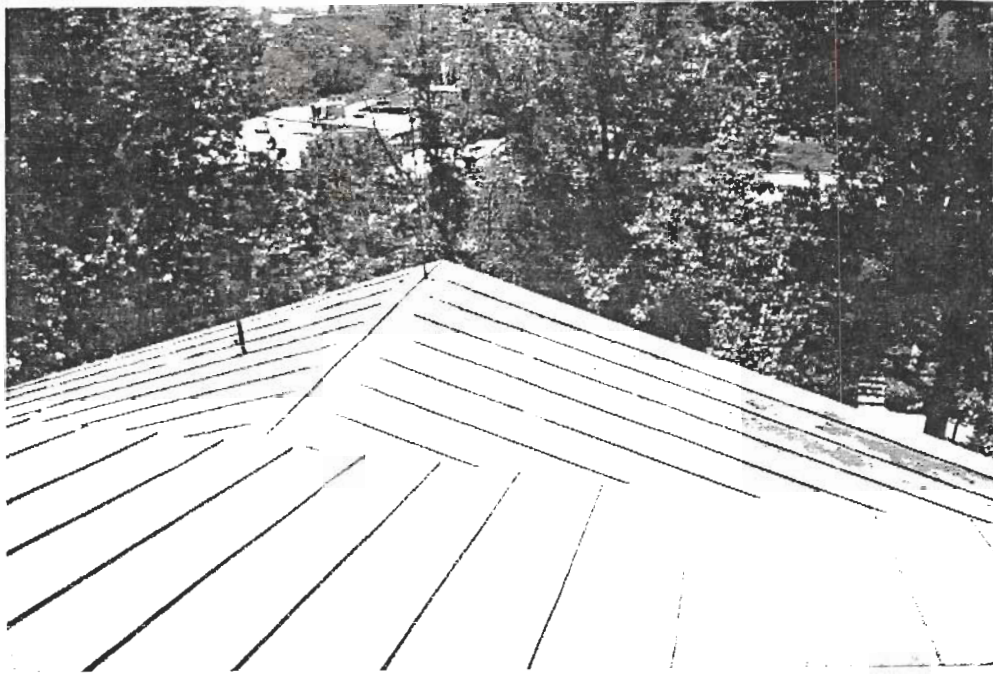
Figure 104

The upper roof is a galvanized standing seam metal roof (not original) covering the central axis and north and south pediments (see Figures No. 37, 94, 95, 96, 97, 98 and 106). Projecting through the mansard roof on all four principal facades are circlehead dormers (see Figures No. 89, 90, 91, 99, 100, 103 and 105) and openings for air conditioners (see Figures No. 92, 99, 100, 103 and 105). The metal roof is in good condition, needing only to be re-coated to maintain its integrity. The slate roof exhibits many loose slate and rusted fasteners and may be nearing the end of its service life. However very few slate are actually dislodged or missing.

Detail of Typical Slate and Flashing at Mansard Roof.

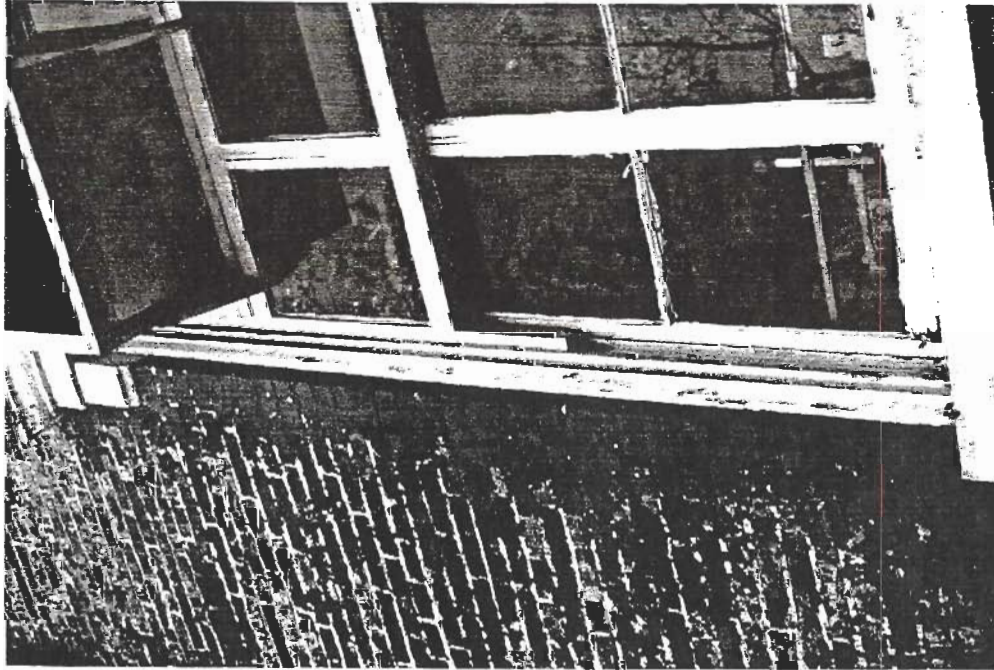
condition. The stone copings at the areaway walls at various locations are dislodged and need to be reset. The floor of the areaway is spalling and broken in places. The masonry mortar joints of the building near the basement level have eroded somewhat (see Figures No. 109 and 120) near the downspouts and cast iron boots.

The mortar at the brickwork near the downspouts has been washed out of the joints at the basement level. Overall the masonry appears to be in good condition, although the mortar is loose and friable in places. In general the brickwork appears stable with few loose elements (see Figures No. 109 and 120).

The masonry areaways that form a moat like separation between the building and the surrounding site (see Figures No. 42, 109, 112, 113, 114, 115, 116 and 118), are capped with both cut granite stones and rough hewn stone (possibly sand stone). A number of stones have been dislodged and must be reset. Access to the basement from grade level to the basement level is via various stone stairs with open risers (see Figures No. 113 and 115). Basement doors occur on all four principal facades. The narrow (approximately four feet wide) areaways open into a large patio type area at the north east facade directly in front of one of the basement doors (see Figure No. 107). The brick retaining walls are stable but in need of tuck pointing where exposed (see Figure No. 112). The masonry is generally covered by a concrete parging scored to appear like large stone blocks. (Also see Appendix A, Section 8.2)

Figure 109 Areaway and Wood Ramp at Northeast Corner.

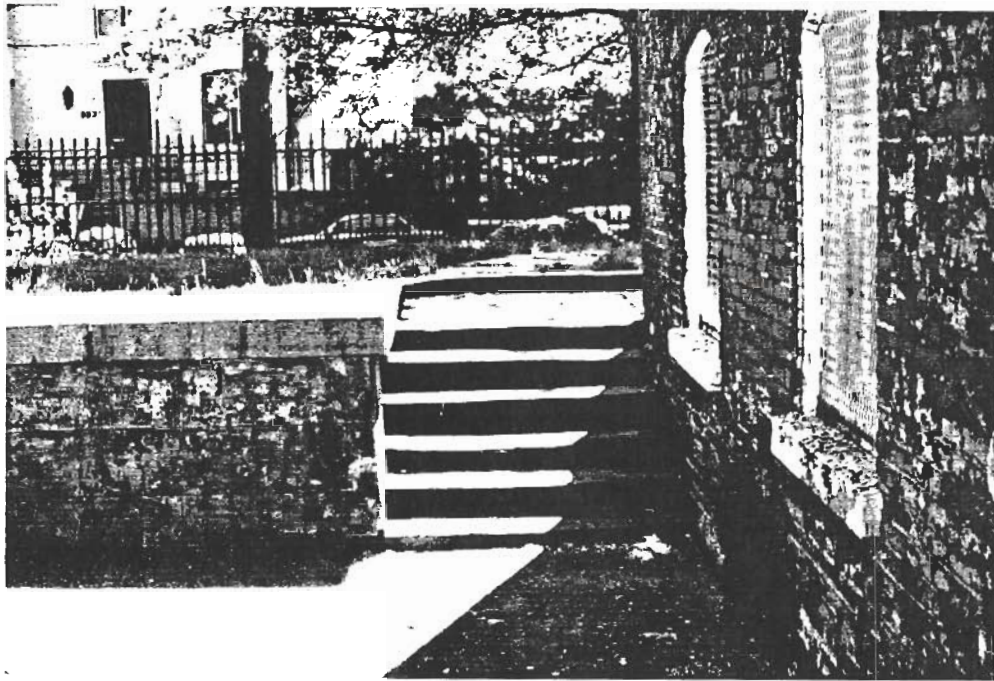
Figure 112 East Areaway Retaining Wall.

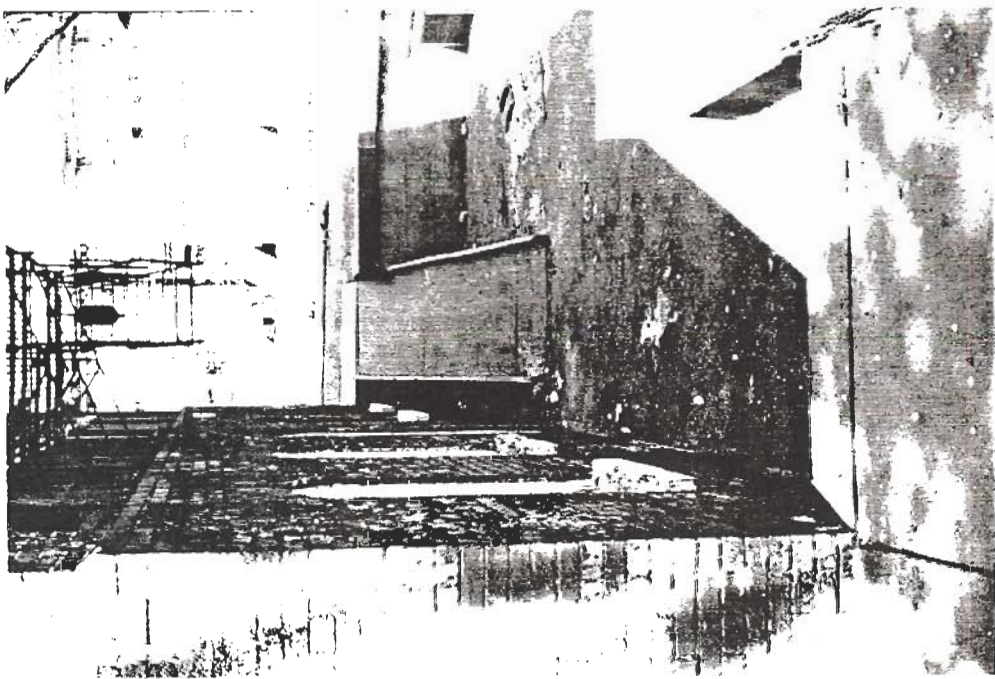
Figure 113 East Areaway Looking South at Stairs.

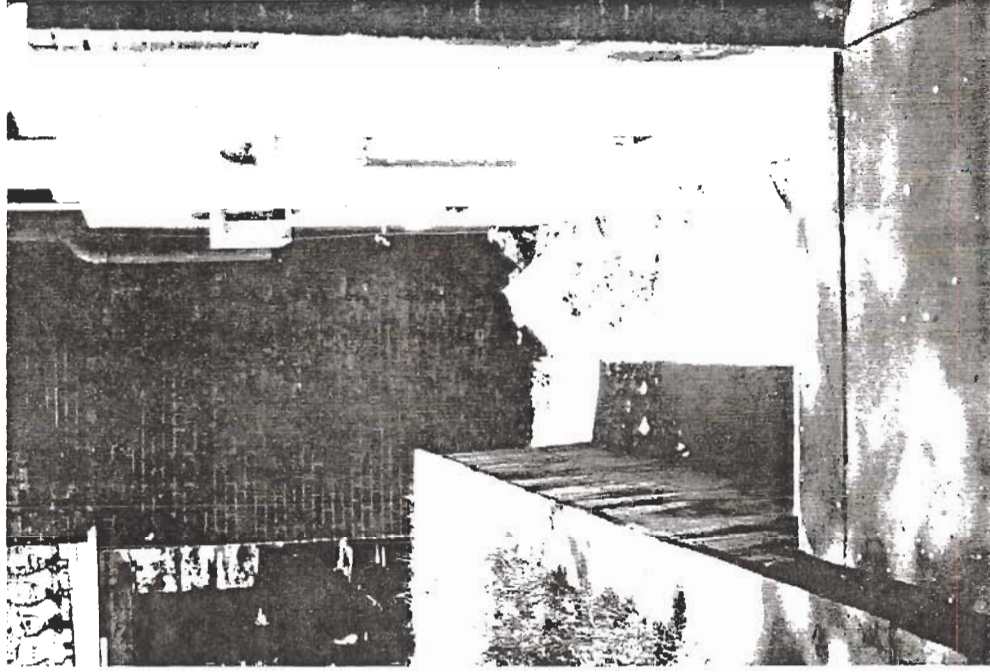
Figure 114 East Areaway and Handicapped Ramp

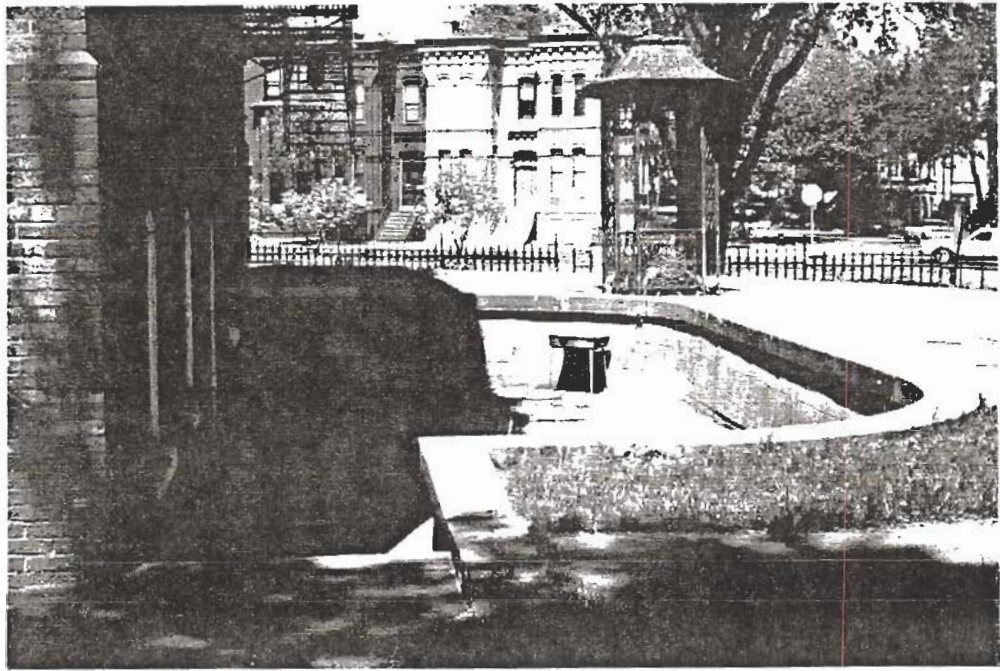
Figure 115 Southeast Areaway.

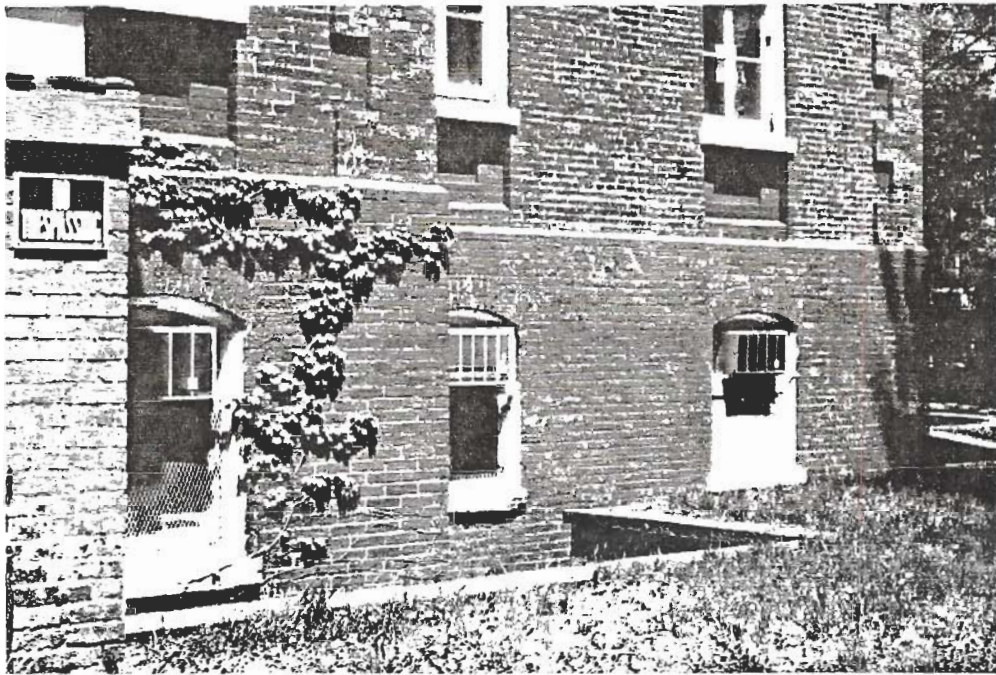
Figure 118 Southeast Elevation at Basement Level.

The basement windows are wood, arched head, casement type wood windows with four lites, set in a brick arched opening (see Figures No. 118 and 122) with stone sills. A significant number of the basement windows have been altered or have the window sashes removed entirely (see Figures No. 29 and 30).

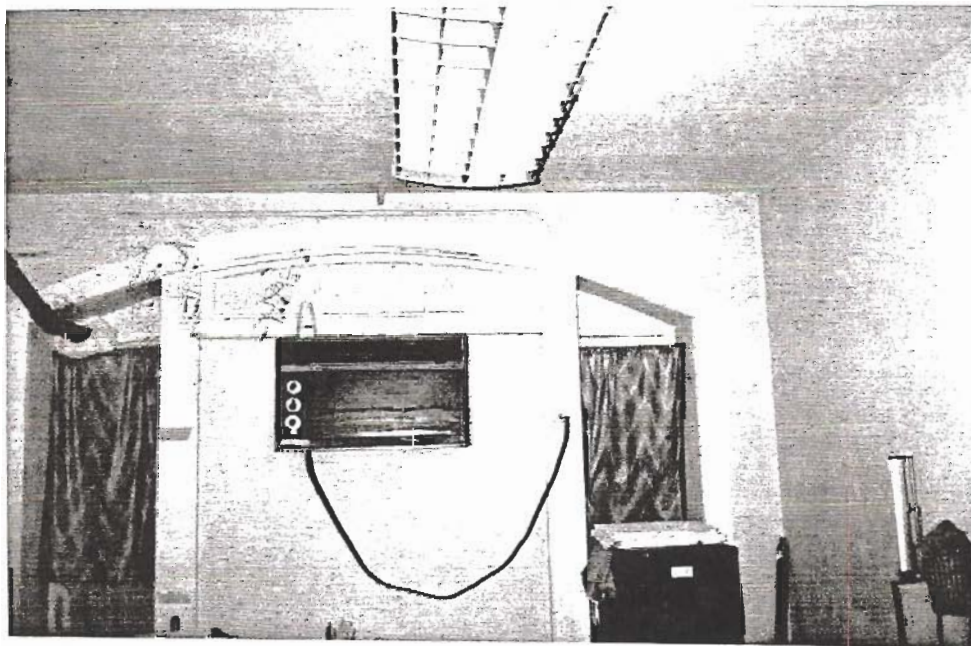
Figure 119 Basement Level Looking South Along North/South Axis.*

The existing electrical system is a series of exposed subpanels located at various places throughout the building including the first floor main hall. Lighting is a mixture of incandescent and fluorescent ceiling mounted fixtures all of recent vintage (see Figures No. 119 and 154). Electrical outlets are a non-grounded type.

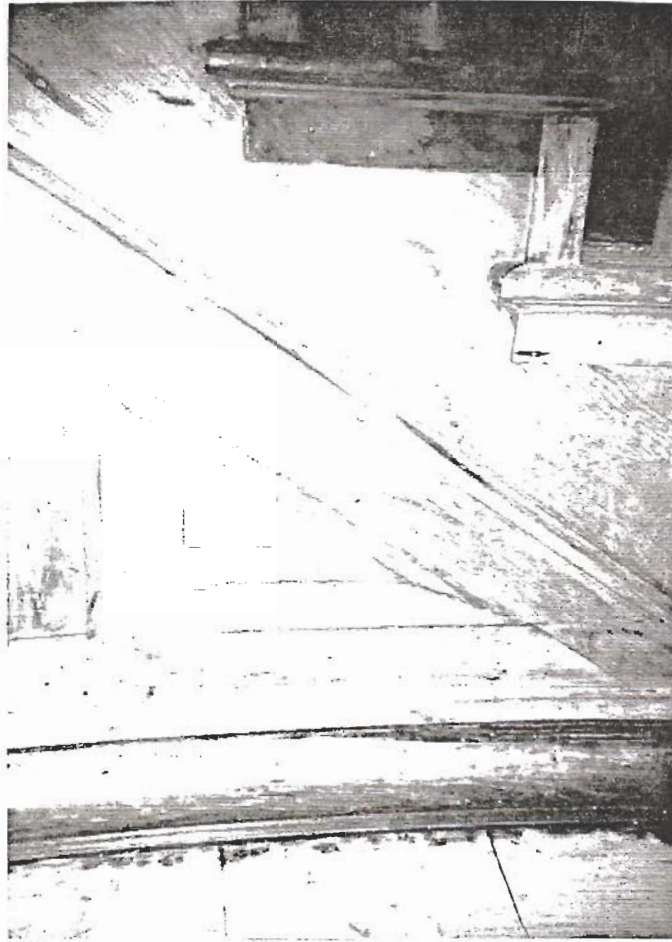
The main (wood) stairway, balustrade and posts are relatively intact from the basement to the third floor (see Figures No. 43, 49, 50, 125, 128 and 129). Several balusters and staircase trim elements are damaged and/or missing (see Figures No. 130 and 131). The basement sidewalls exhibit the original or early beaded board wainscoting (see Figures No. 65 and 129) paralleling the basement stair.

Figure 130 First Floor Stair - Side View.*

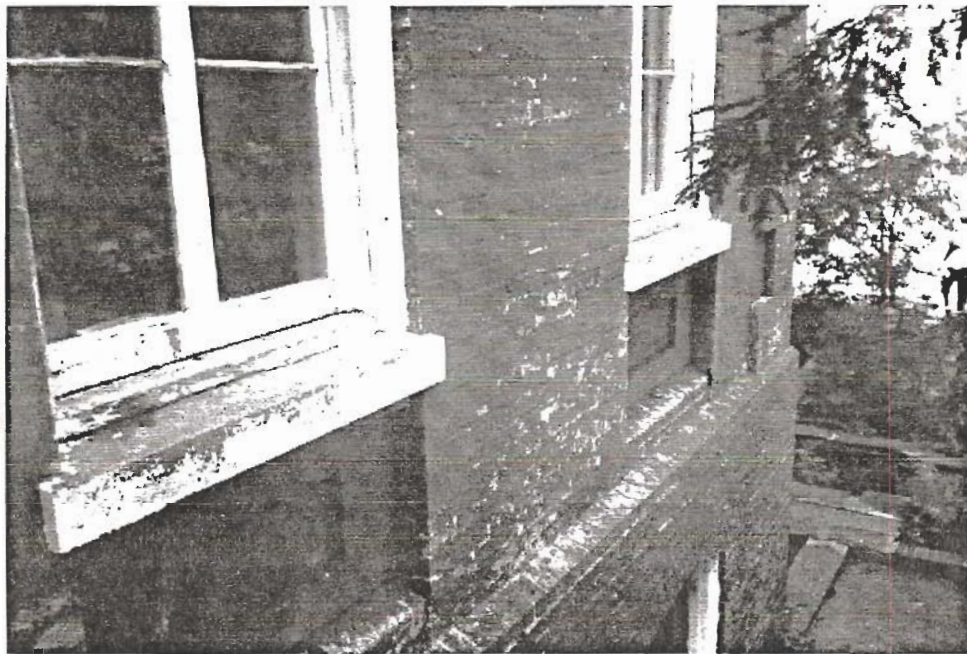
Figure 134 First Floor Window Sill and Recessed Brick Panels, Exterior View, at North Facade.*

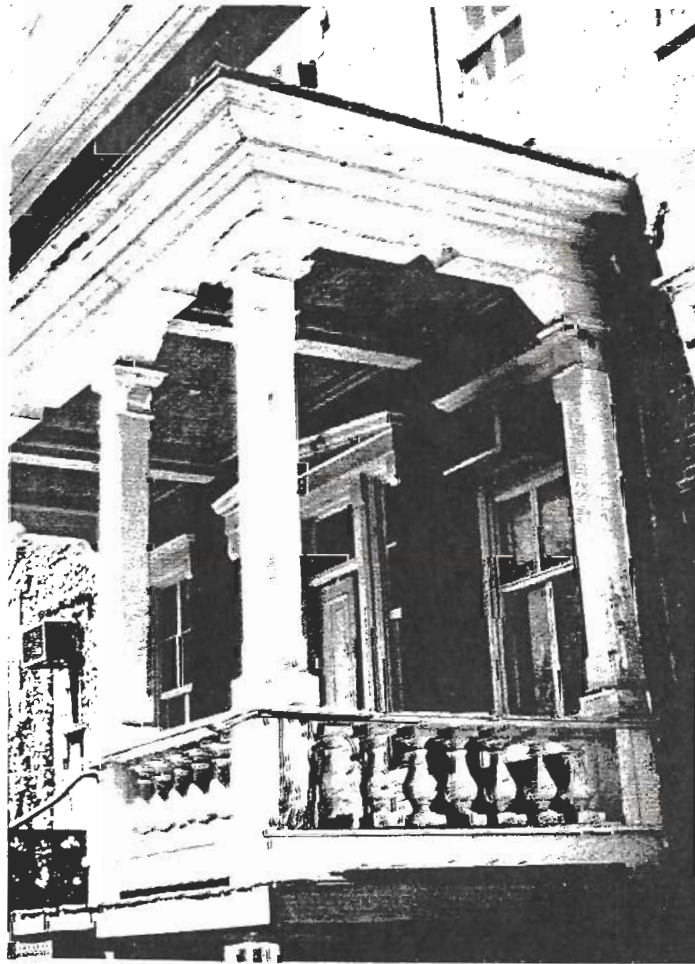
Figure 141 East Side Elevation of South Entrance Portico.

The south entrance exhibits a wood portico (see Figures No. 32) covering the entrance, flanking windows (sidelights) and left and right double hung windows. The metal roofed portico is supported by four chamfered columns with pilasters at the building wall (see Figure No. 141). Spanning between the columns are circular wood balusters supporting a (deteriorated) top rail (see Figures No. 140 and 142). The early or original porch flooring is 2 to 2-1/2 inch wide wood planking (similar in width to the interior original flooring). The wood beaded board ceiling is divided into three coffers by wood ceiling beams coinciding with the chamfered columns (see Figures No. 141 and 144). Cast iron lanterns (see Figure No. 59) on a stone base frame the base of the cast iron stairs (see Figure No. 78). The stair railing consists of a single (early but not original) pipe rail similar to the rail at the lower concrete stair at the north entrance. The south entrance cast iron stairs are in deteriorated condition. The stair stringers are cracked and numerous risers are missing or damaged (see Figure No. 143).

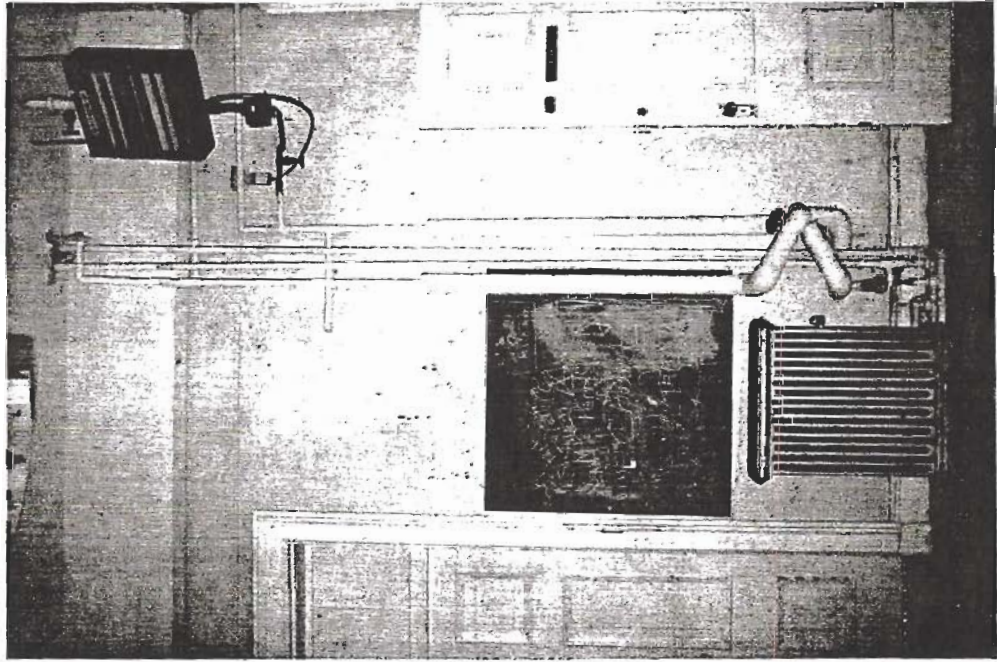
Figure 150 Second Floor North Wall Typical Office/Classroom.

The first and second floors of the interior of the Hospital exhibit the fifteen foot high ceiling heights (see Figures No. 51, 52 and 150) and axial plan (see Figures No. 51 and 70) of the original construction. The third and basement floors have undergone more extensive renovations and/or changes and contain dropped or furred ceilings (see Figures No. 119, 124 and 154). All floors contain a number of the original wood-paneled doors (see Figures No. 48, 52, 55, 66, and 136), door surrounds (see Figures No. 68, 69 and 70) transoms (see Figures No. 54 and 70). Early or original hardware is visible at some of the corridor doors (see Figure No. 67), combined with various contemporary items added by various tenants.
